Cultural Resources Assessment for the Skagit Valley Family YMCA, Mount Vernon, Skagit County, Washington

APPENDIX B
Geotechnical Boring Memo

Date: November 7, 2011
File: 20295-001-00
Subject: Preliminary Findings and Conclusions
Mount Vernon Skilled Nursing Facility – Eagle Health Care

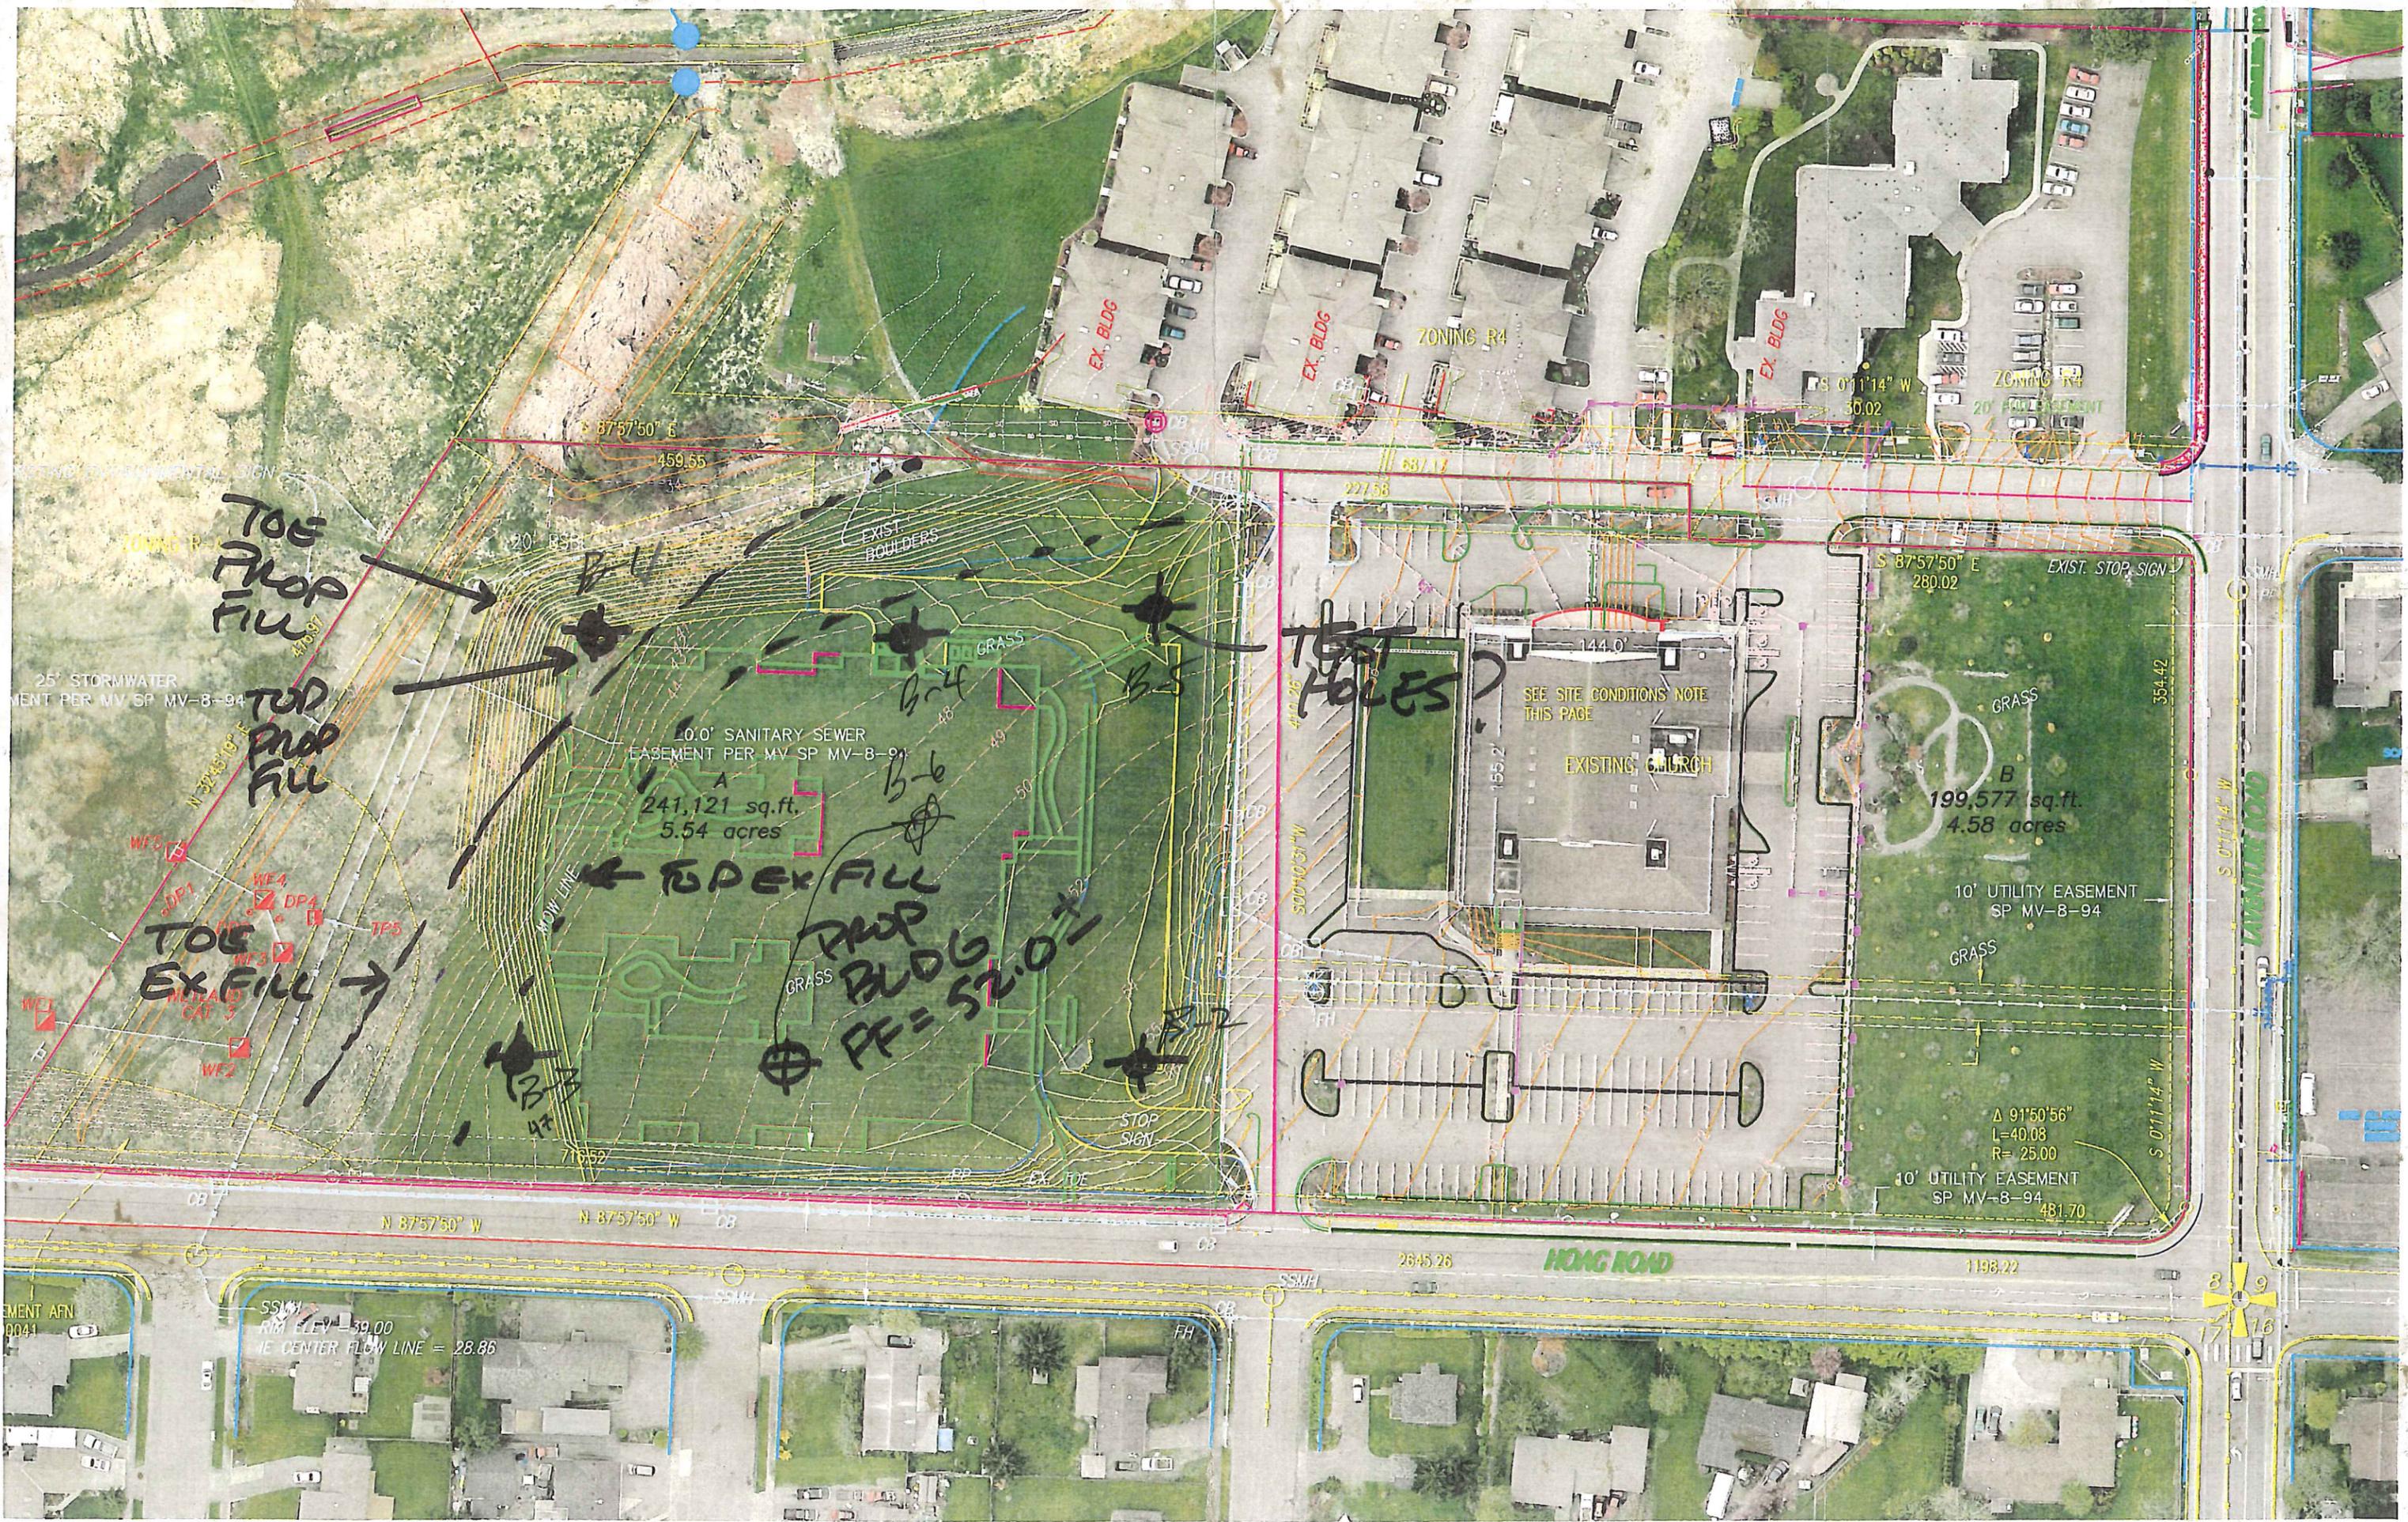
TOE PROP FILL
TOP PROP FILL
TOE EX FILL

PROP BLDG
PF = 52.0'

TEST HOLES

SEE SITE CONDITIONS NOTE THIS PAGE

We completed six borings on November 1 and have finished most of our laboratory testing program. The locations of the borings were similar to those proposed by Pat Severin of Sound Development, with the exception that we moved B-6 to the “middle” of the site (see marked up figure attached to e-mail). Depending on conditions encountered during drilling, the borings were completed to 11½ to 36½ feet below existing ground surface (bgs). B-1 was completed to 31½ bgs to look at potential settlement of native soils, B-6 was completed to 36½ to confirm the soil profile encountered at depth in B-1.

- The underlying native soils consisted of stiff to very stiff silt/clay (Recessional Marine Drift) over dense sand (Advance Outwash). At B-1, which was accomplished outside of the fill prism, we observed about 2½ feet of topsoil and weathered soil over the stiff silt and dense sand. At B-6, which was completed deeper to correlate with B-1, we observed a similar profile.
